# Intel® Pentium® 4 Processor

## Specification Update

*June 2003*

Document Number: 249199-038

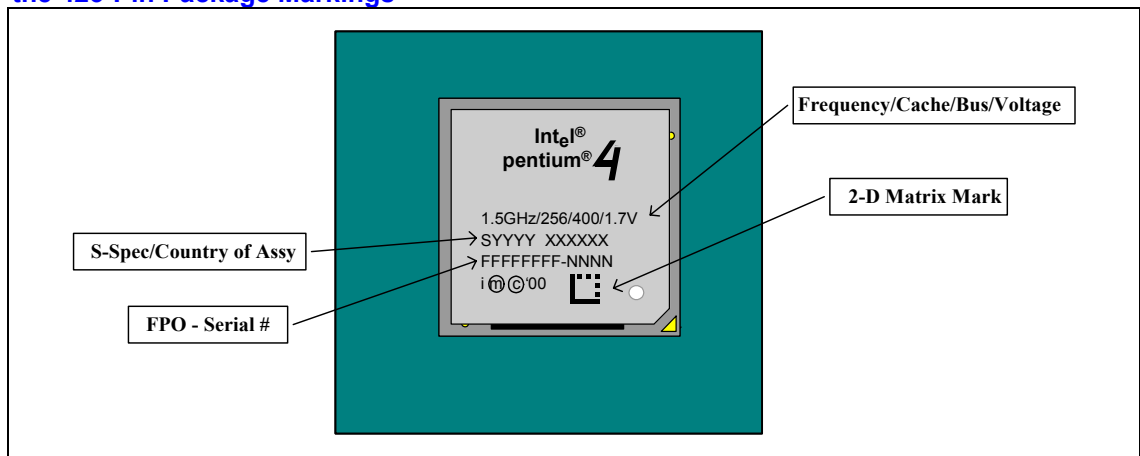
**Figure 1. Intel® Pentium® 4 Processor in the 423-Pin Package and Boxed Pentium 4 Processor in the 423-Pin Package Markings**

The Pentium 4 processor may be identified by the following component markings:

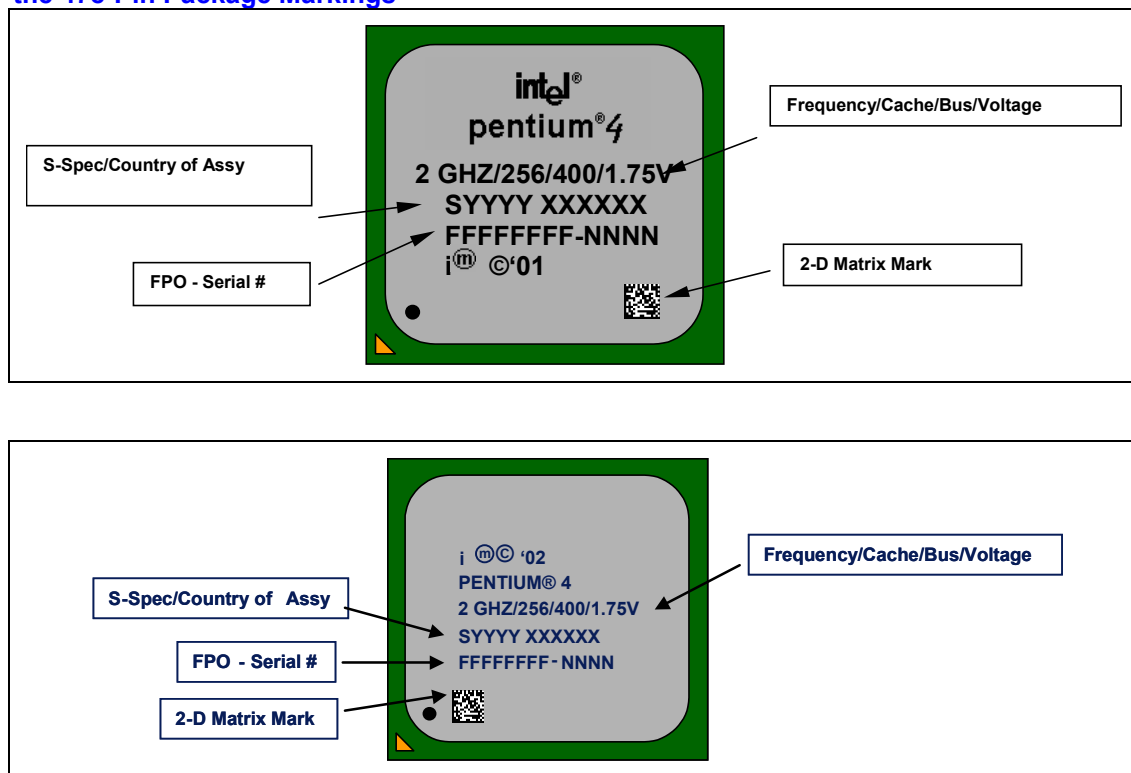
**Figure 2. Intel® Pentium® 4 Processor in the 478-Pin Package and Boxed Pentium 4 Processor in the 478-Pin Package Markings**

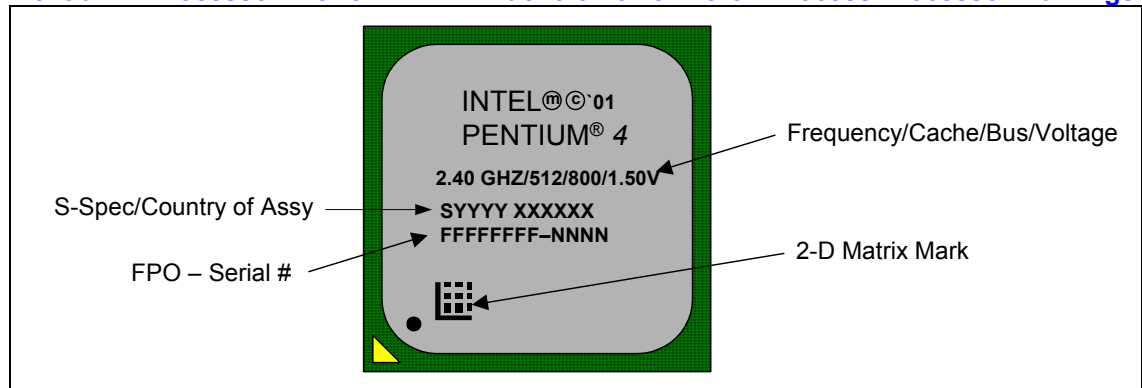
**Figure 3. Intel® Pentium® 4 Processor with 512-KB L2 Cache on 0.13 Micron Process and Boxed Pentium 4 Processor with 512-KB L2 Cache on 0.13 Micron Process Processor Markings**

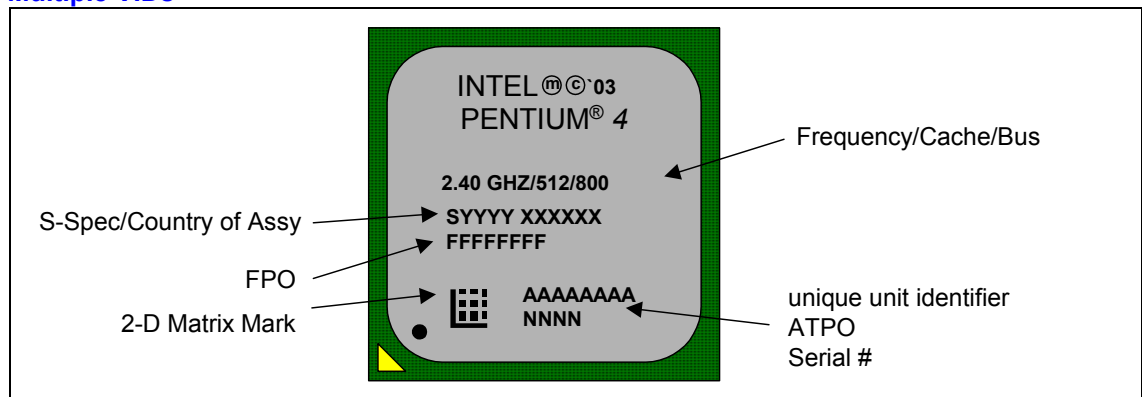
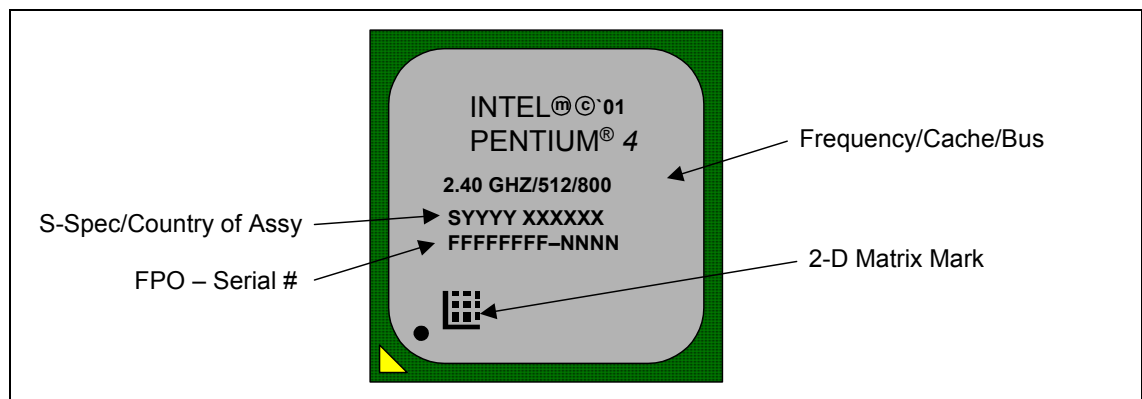
**Figure 4. Multiple VIDs**
